# Manhole Inspection Summary

Manhole # S03AA2017MH

**Location** Address: **3201 PINKNEY RD**

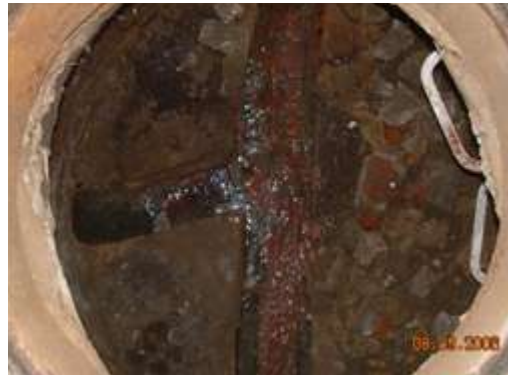
Top View

Evidence of surcharge - Bench debris.

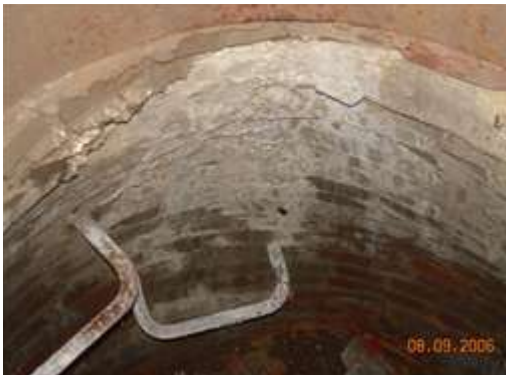
Defect

Frame leaks. Adjustment and Barrel infiltration.

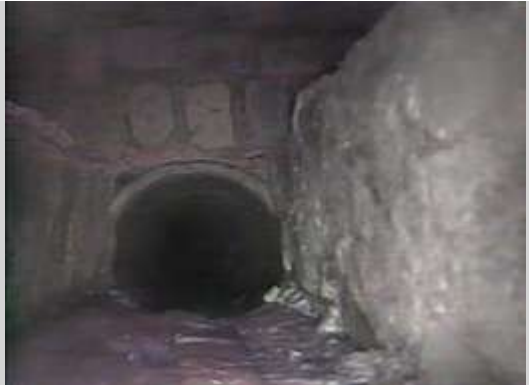
### 8 in. Circular Gravity Sewer Pipe Out @ 12 O'Clock

Comments **The O12 pipe seal is not flush with pipe. The O12 pipe picture shows grease deposits in the Channel.**

Infiltration: **Evidence** Pipe Seal Cond: **Unknown**

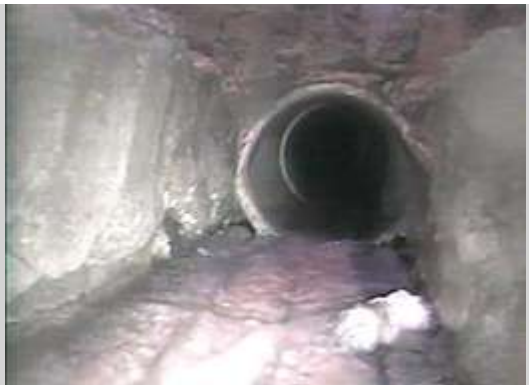
### 8 in. Circular Gravity Sewer Pipe In @ 6 O'Clock

Infiltration: **Evidence** Pipe Seal Cond: **Unknown**

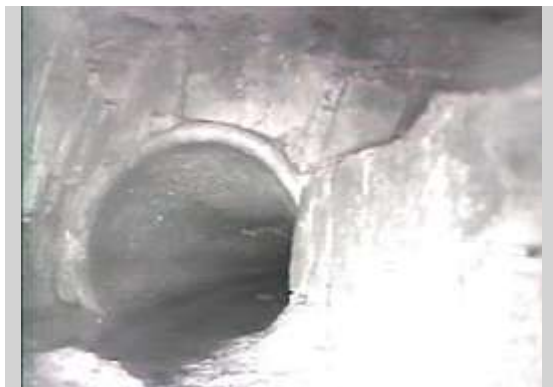
Pipe In @ 9 O'Clock

Infiltration: **Evidence**

Pipe Seal Cond: **Cracked**
